# Minc Elevator Consulting - Specialist Expert Advice

## Gold Coast High Rise - Lift Accident Investigation

## Indooroopilly Shopping Centre - Excessive Step Noise from Escalators

## Brisbane - Lift Failure Investigation

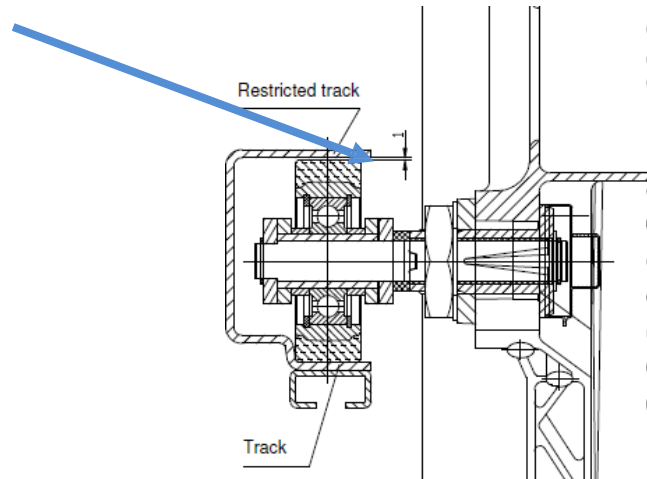
Figure 3.

The recommended clearance between the top of the chain roller and the guidance channel is 1mm. ( see figure 3).This is confirmed by 3 other major Escalator suppliers, Schindler, ThyssenKrupp and Anlev. (Note: Anlev are a major supplier to Asia and other parts of the world and are a specialist Escalator manufacturers).

This dimension provides ample clearance for the step chain to run smoothly and as to not have pressure on the chain and prevent chain crabbing.

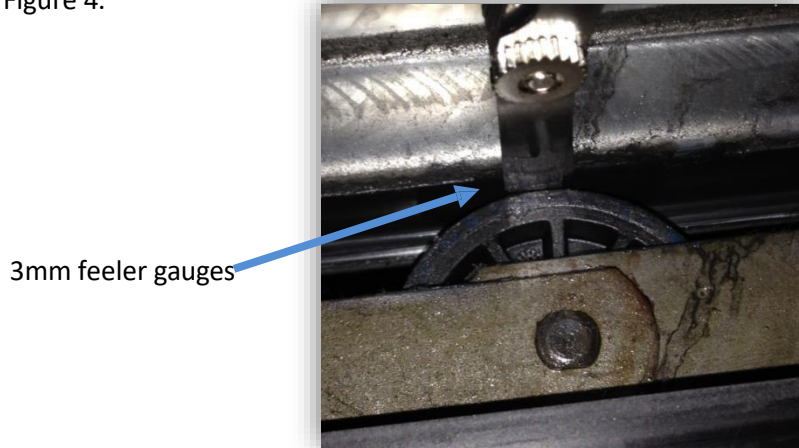
Figure 4.

An inspection of Escalator 16 identified a clearance dimension of 3 mm between top of the Step Chain Roller and the Guidance channel. In the opinion of Minc Elevator Consulting this is deemed to be a contributing factor in the step rock dimension measured. (See figure 4)

It was also noticed that the Tension on the step chain on Unit number 16 may not have been as required by the manufacturer.

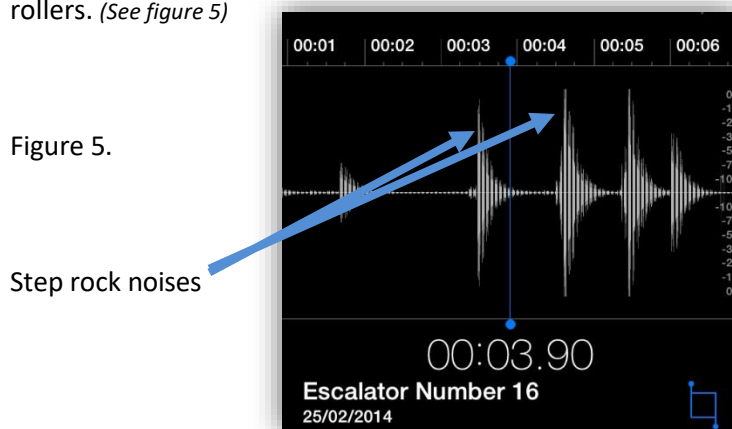
Figure 5.

Escalators 15 and 16 also displayed an unusually loud knocking noise when passengers stepped on the escalator steps. This noise is well above acceptable levels and could contravene Clause 11.2 of the project specification.

An inspection of the Escalator determined the most likely source of the noise being the escalator step pin hitting the underside of the skirting due to the excessive clearance in the step chain rollers. (See figure 5)

It is the opinion of Minc Elevator Consulting that units 15, 16, 29, and 30 do not meet the requirement of Clause 11.2 of the project specification. The major likely cause being the clearance dimension between the chain step roller and the guide channel of the step chain.

Minc Elevator Consulting suggests that an acceptable standard be established when performing the final inspections of the Escalators at Indooroopilly Shopping Centre. The standard should be established to meet the requirements of Clause 11.2 of the specification.

- Acceptable step rock dimension <4 mm.
- Acceptable Noise levels below 70 Dba from step rock noise.
- The above criteria be maintained throughout the Defects Liability Period.
- Completion of the Defects Liability Period will be subject to these standards being maintained.

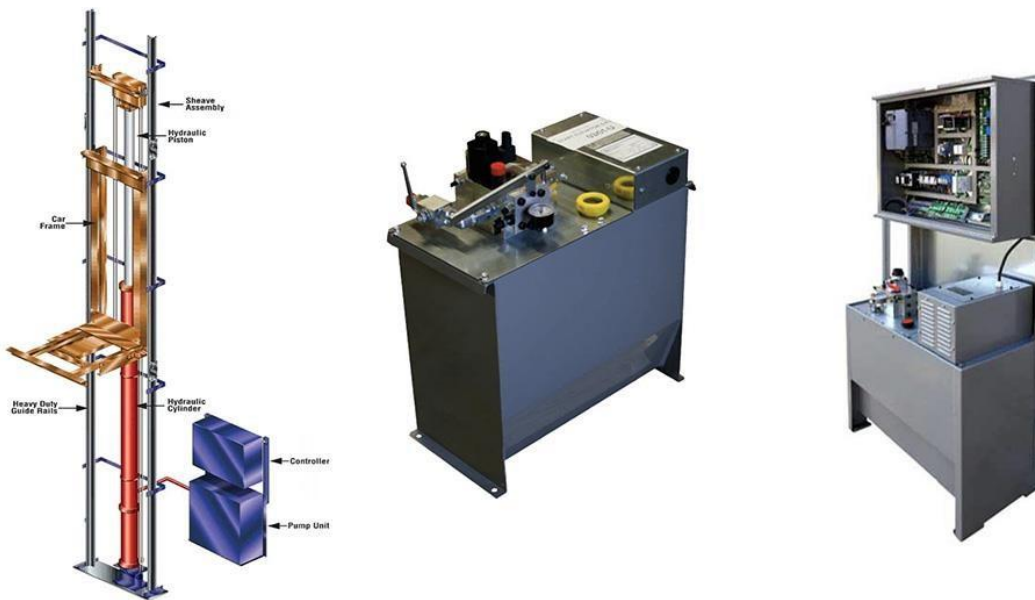
The ongoing problem was the lift was regularly locking itself out of service.

It was identified that the battery was going flat after several months in service, this occurred when the voltage dropped below specified operating values, this locked the lift out of service, necessitating a manual reset by a lift technician.

The root cause why the lift was failing was identified that the trickle charge current was only marginally above the standby current required by the system, so after more than usual traffic the trickle charger could not top up the battery in sufficient time prior to the lift locking itself out of service.

Minc Elevator Consulting recommended getting a charger with a slightly higher capacity which was greater than the standby current consumed by the system and topped up any power consumed during use.
