# Minc Elevator Consulting - Specialist Expert Advice

## Gold Coast High Rise - Lift Accident Investigation

## Indooroopilly Shopping Centre - Excessive Step Noise from Escalators

## Brisbane - Lift Failure Investigation

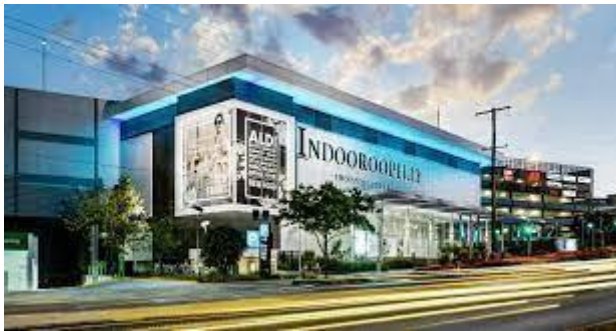
The noise in question was a loud knocking noise when customers travelled and walked on the Escalator steps.

Associated with the step rock is step rock noise which is mainly caused when excessive step rock is occurring, and the step pins are then able to hit the underside of the skirting.

It is the opinion of Minc Elevator Consulting that units 15, 16, 29, and 30 do not meet the requirement of Clause 11.2 of the project specification. The major likely cause being the clearance dimension between the chain step roller and the guide channel of the step chain.

There may be other contributing factors, namely roller wear and chain tension.

- Acceptable step rock dimension <4 mm.
- Acceptable Noise levels below 70 Dba from step rock noise.
- The above criteria be maintained throughout the Defects Liability Period.
- Completion of the Defects Liability Period will be subject to these standards being maintained.
